# Summer 2025 Research Project

**Vivian Maneval**  
**Ecological Restoration Science Intern**

How does the vegetation **community structure and productivity** of restored living shorelines compare to **unrestored** fringing marshes across three paired sites in the Severn River?

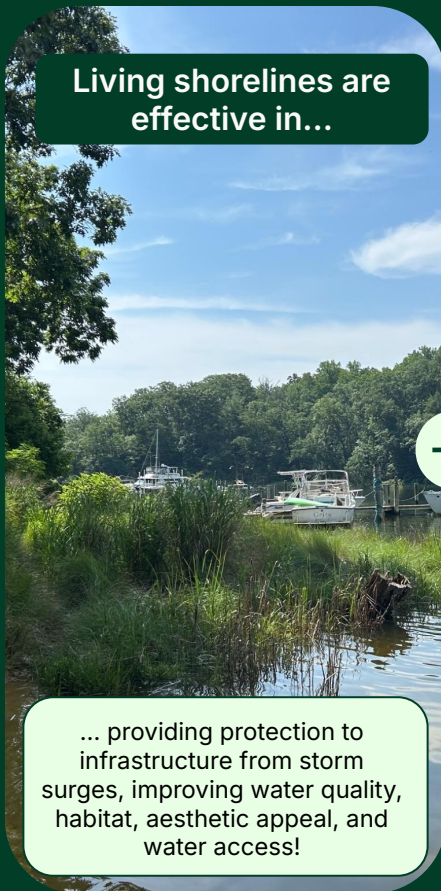
Living shorelines are effective in...

... providing protection to infrastructure from storm surges, improving water quality, habitat, aesthetic appeal, and water access!

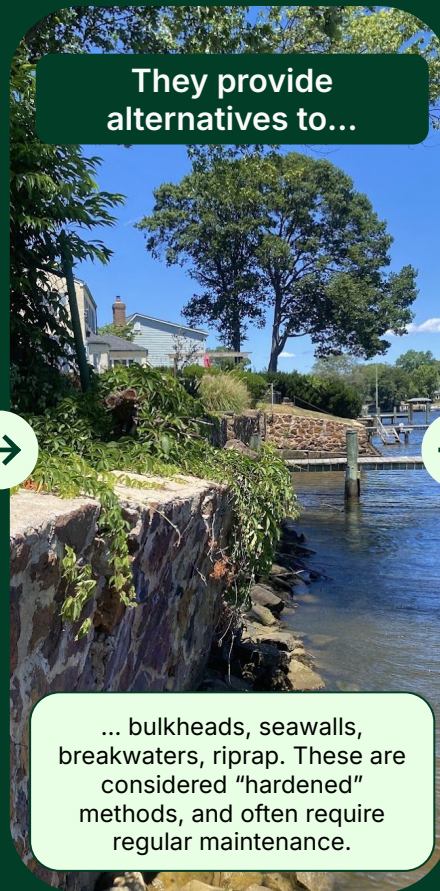
They provide alternatives to...

... bulkheads, seawalls, breakwaters, riprap. These are considered "hardened" methods, and often require regular maintenance.

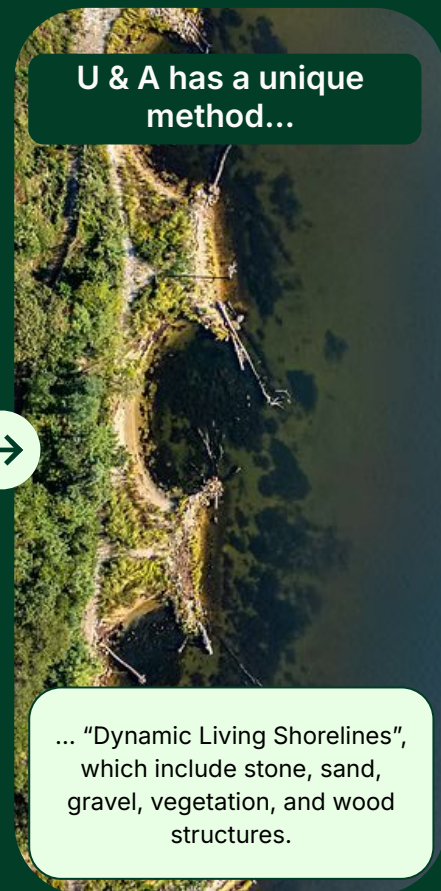
U & A has a unique method...

... "Dynamic Living Shorelines", which include stone, sand, gravel, vegetation, and wood structures.

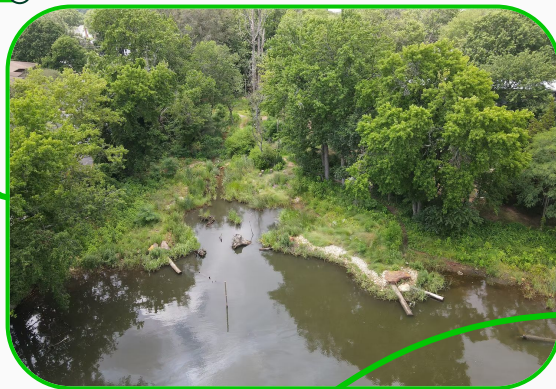
#### St. Luke's

Fetch: 0.16km (0.1 mi)  
Bank Height: 0-1.5m  
Site Length: 15m

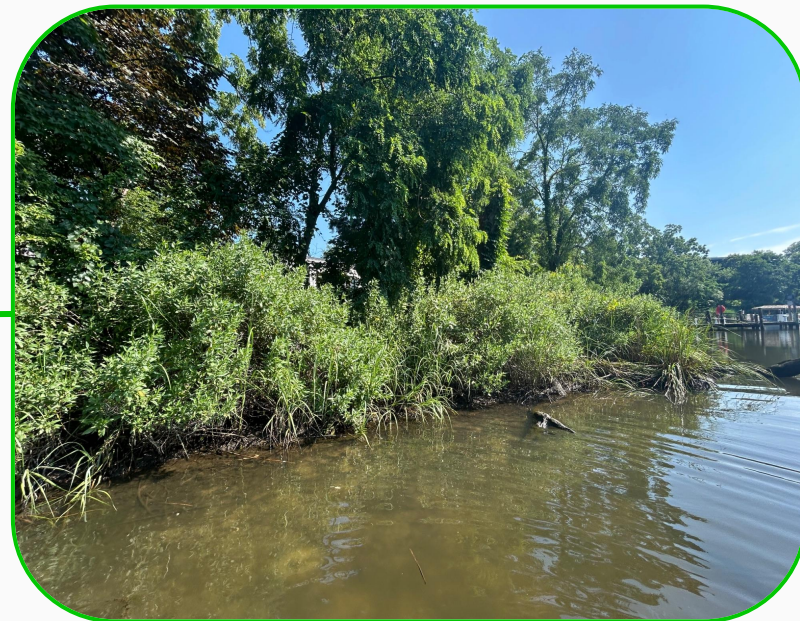
#### Nautilus Point Marina

Fetch: 0.12km (0.07 mi)  
Bank Height: 0-1.5m  
Site Length: 18m

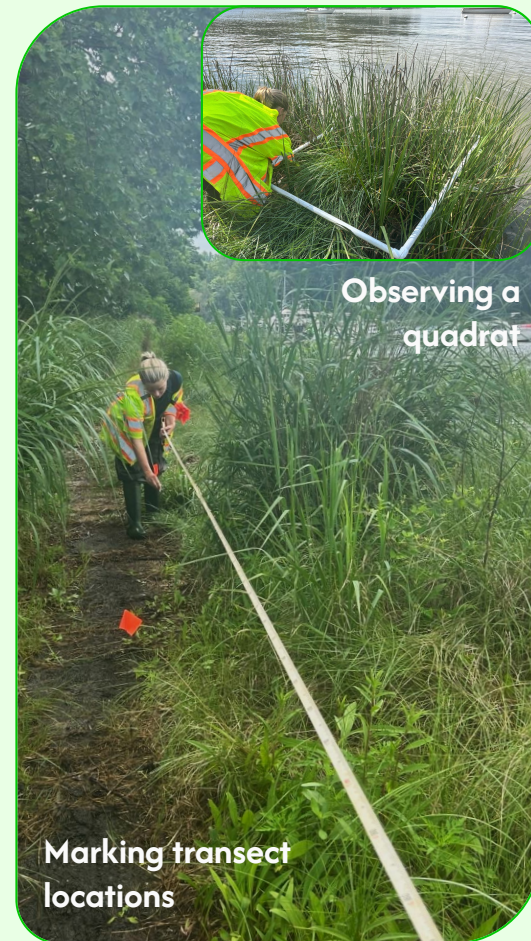
Observing a quadrat

Marking transect locations

## Protocol Specifics

**6** Sites studied

**1/5** Of each site length was measured

**2** Random 1m x 1m quadrats per transect

**3m** Separation between transects

**10m** Maximum width measured

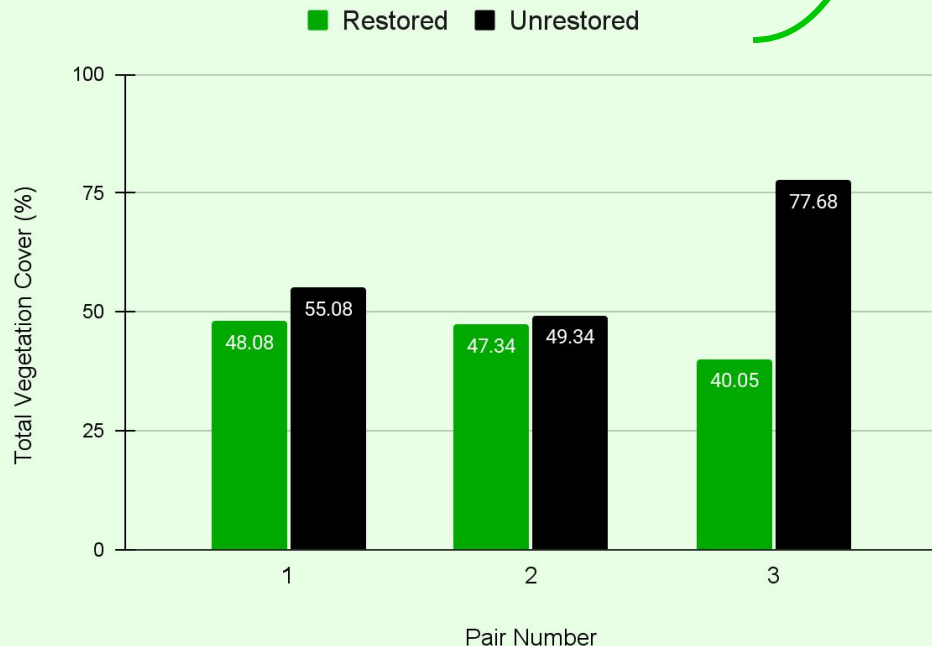
Percent Vegetative Cover at Site

Unrestored sites had higher % cover within all three pairs.

This may be a result of multiple causes:

- Living shorelines often contain **bare areas** for habitat provisioning, recreational use, and as a result of the headland + embayment system.
- Invasive species are generally **denser**, leading to higher % cover at unrestored sites (e.g., *Phragmites australis* stands).
- **Higher vegetation cover ≠ healthier**

$$\text{Total Vegetation Cover} = \frac{\sum \text{Freq. of cover class} \times \text{Midpt. of cover class}}{\text{Number of quadrats at site}}$$

Unrestored sites had higher cover at all three sites. Likely cause: density of invasive species & restoration design.
